CONFIDENTIAL BUREAU OF SHIPS OPERATION CROSSROADS. J.S.S. LST 52 TEST BAKER US U. S. GOVERNMENT AGENCIES MAY OBTAIN COPIES OF THIS REPORT DIRECTLY FROM DDC. OTHER QUALIFIED DDC USERS SHALL REQUEST THROUGH Defense Atomis Support Agenc Washington, D. C. 20301 1947, OPERATION CROSSROADS DIRECTOR OF SHIP MATERIA JOINT TASK FORCE ONE JISIA E REG. NO. CONFIDENTIAL 9 190 (193600)

BUREAU OF SHIPS GROUP TECHNICAL INSPECTION REPORT

USS LST 52

TECHNICAL INSPECTION REPORT

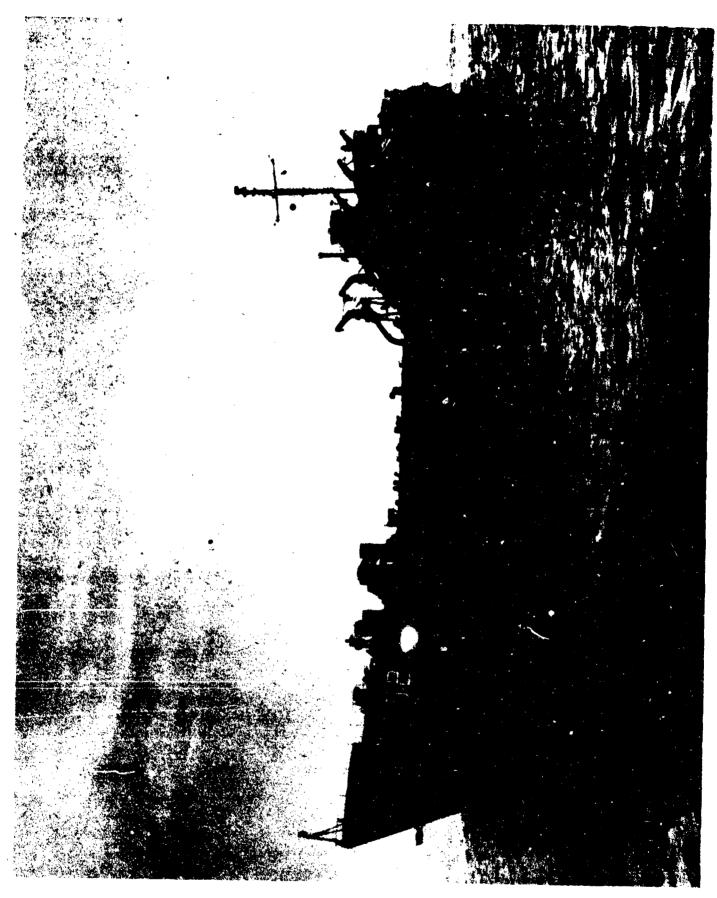
AB-CR-227-289-151. View from off port bow after Test A.

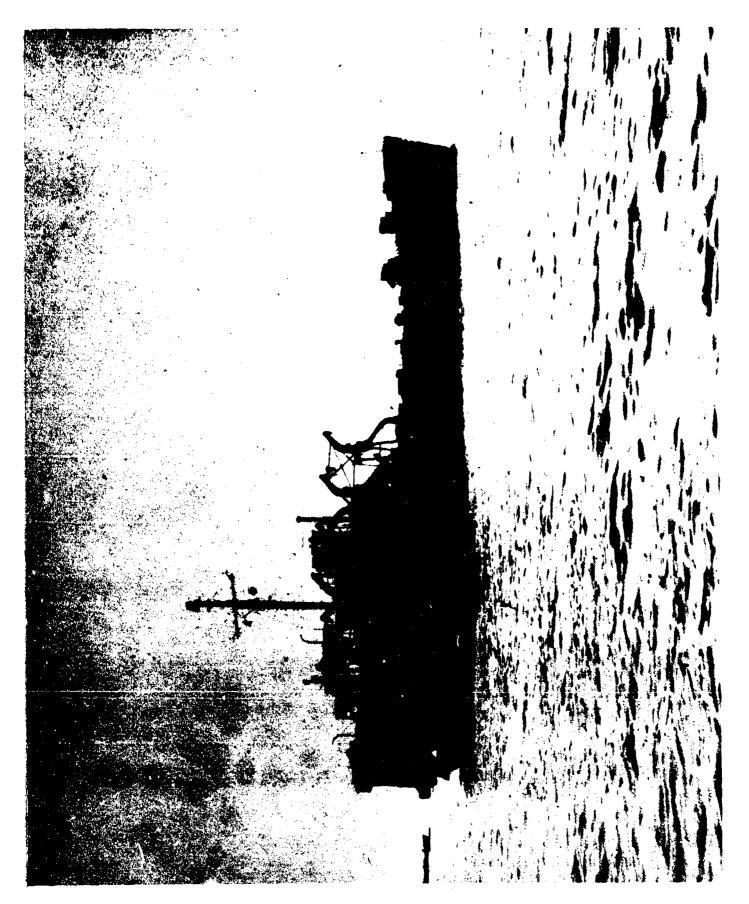
AB-CR-227-289-147. View from off starboard quarter after Test A.
